**CAPE COD CANAL  
BOURNE, MASSACHUSETTS**

# **BOURNE HIGHWAY BRIDGE MAJOR REHABILITATION**

## **DESIGN MEMORANDUM**

**NOVEMBER 1963**

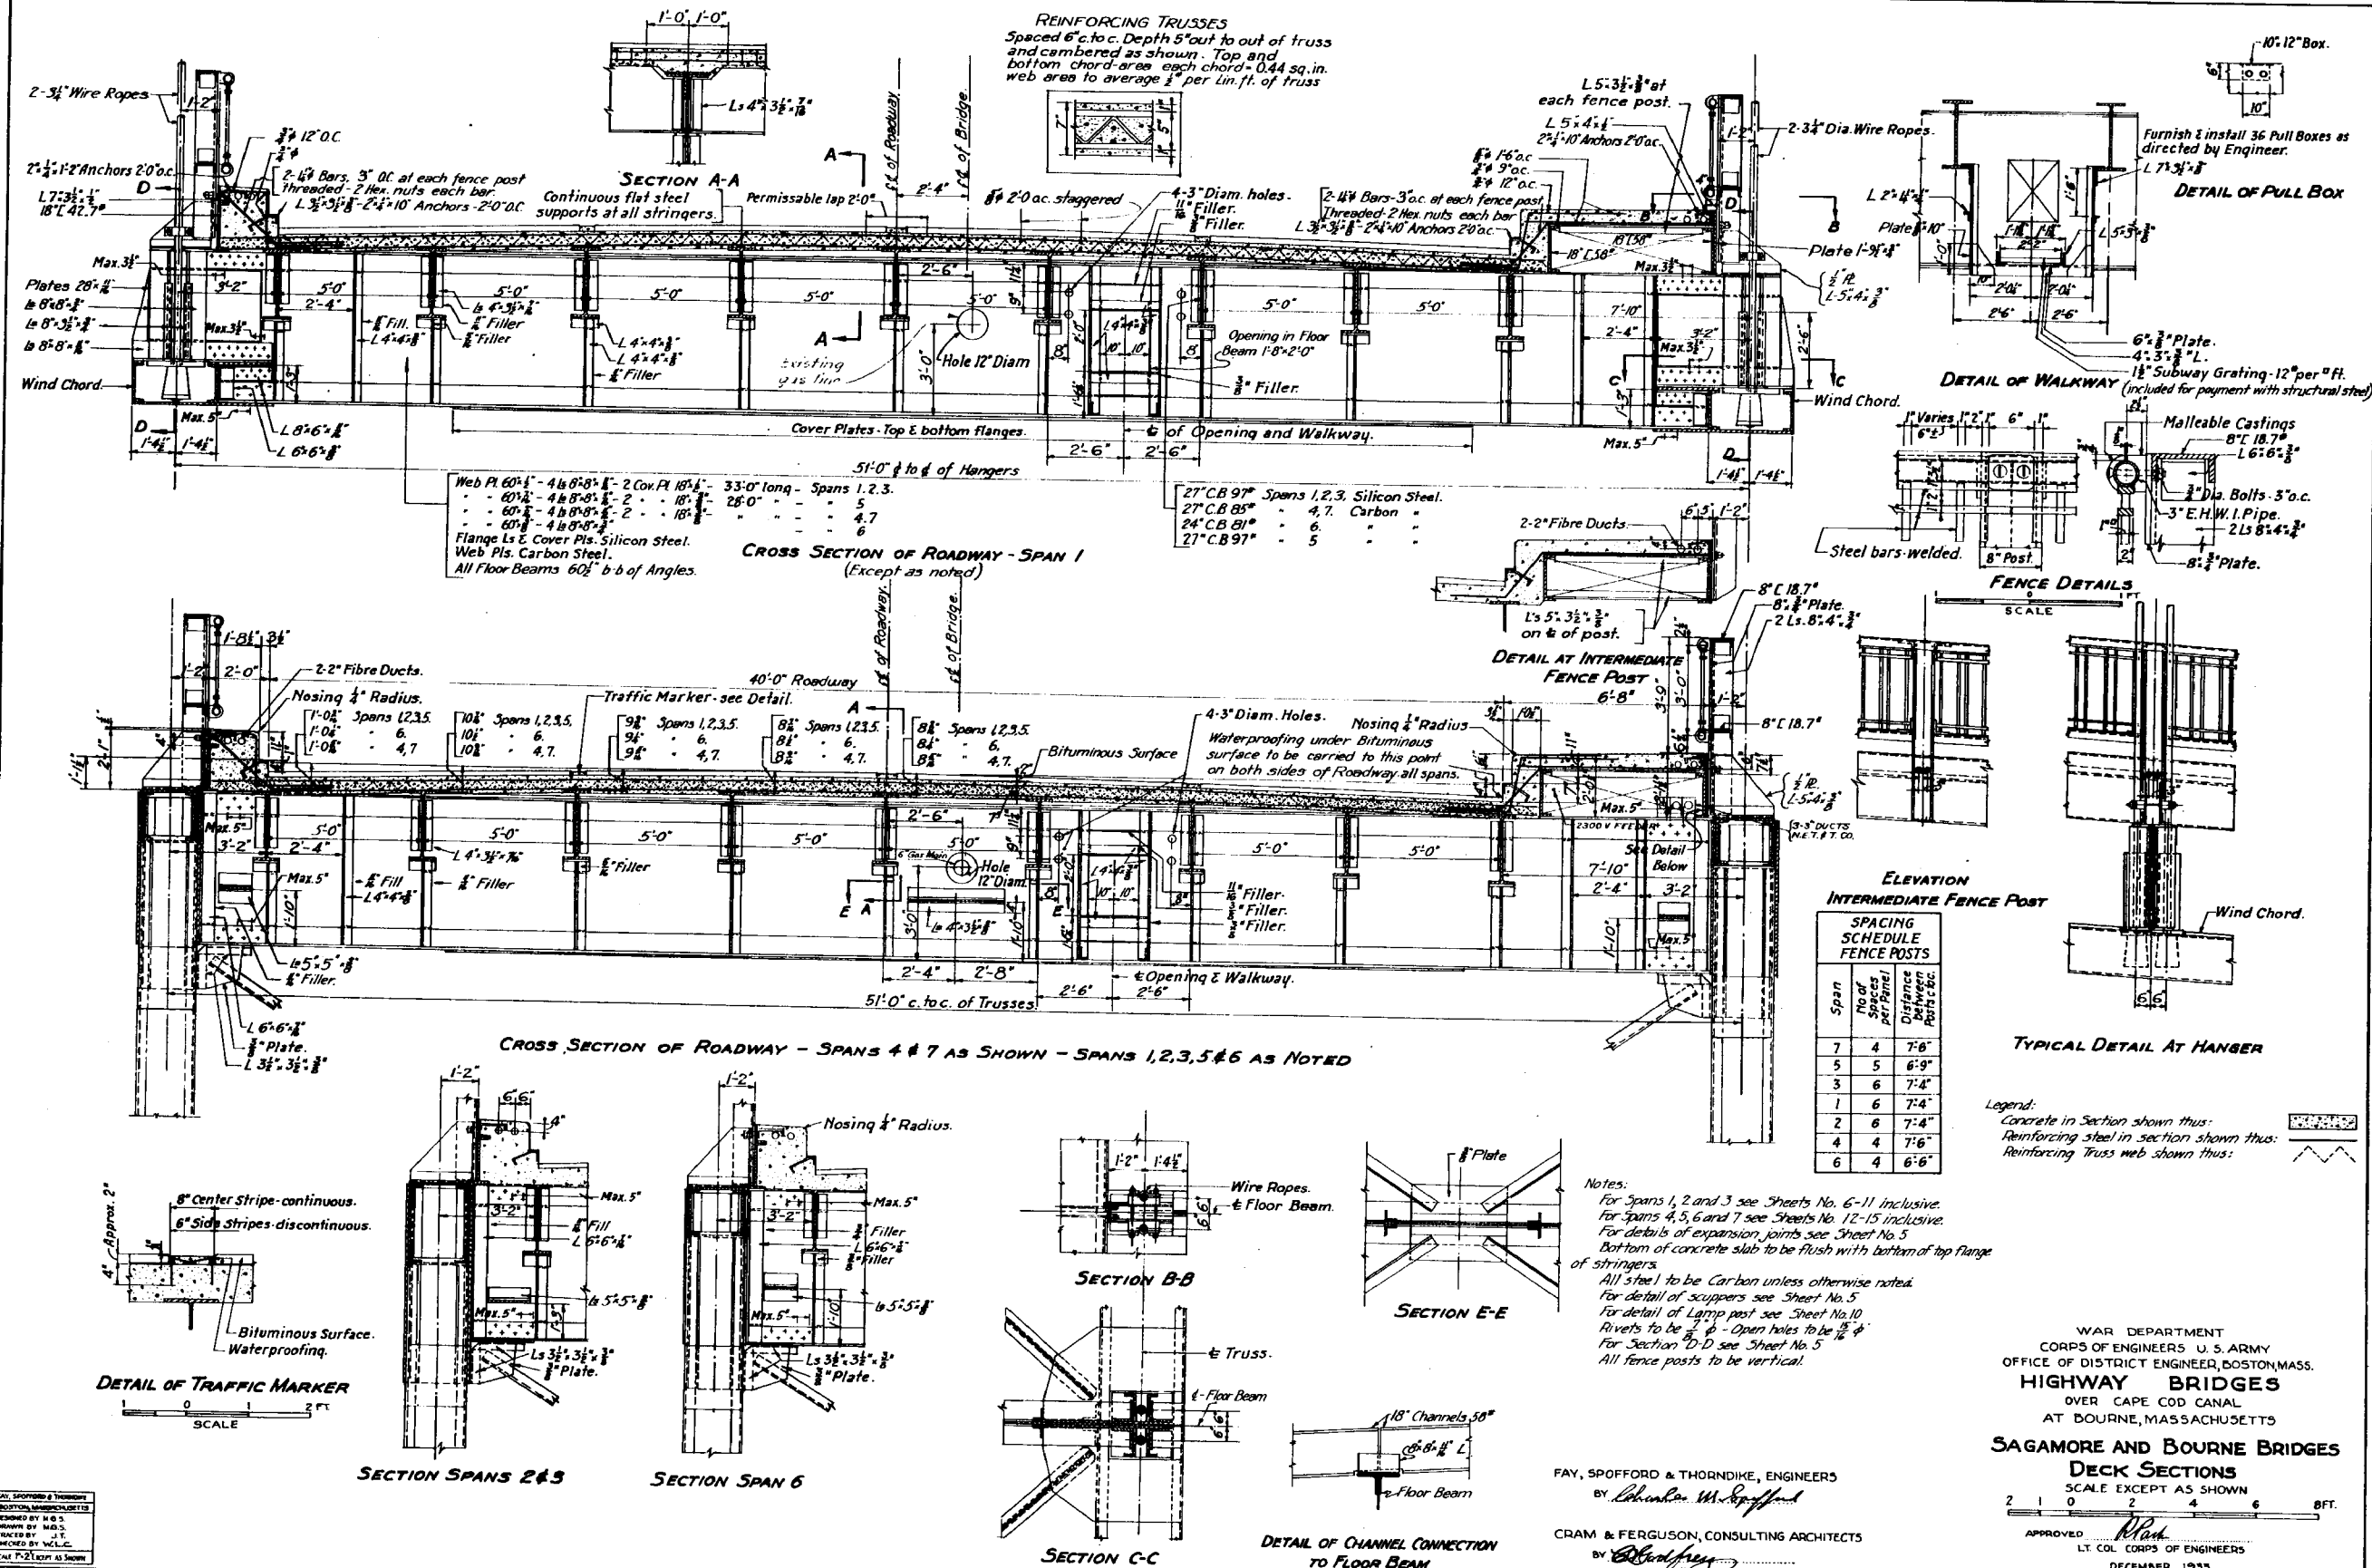
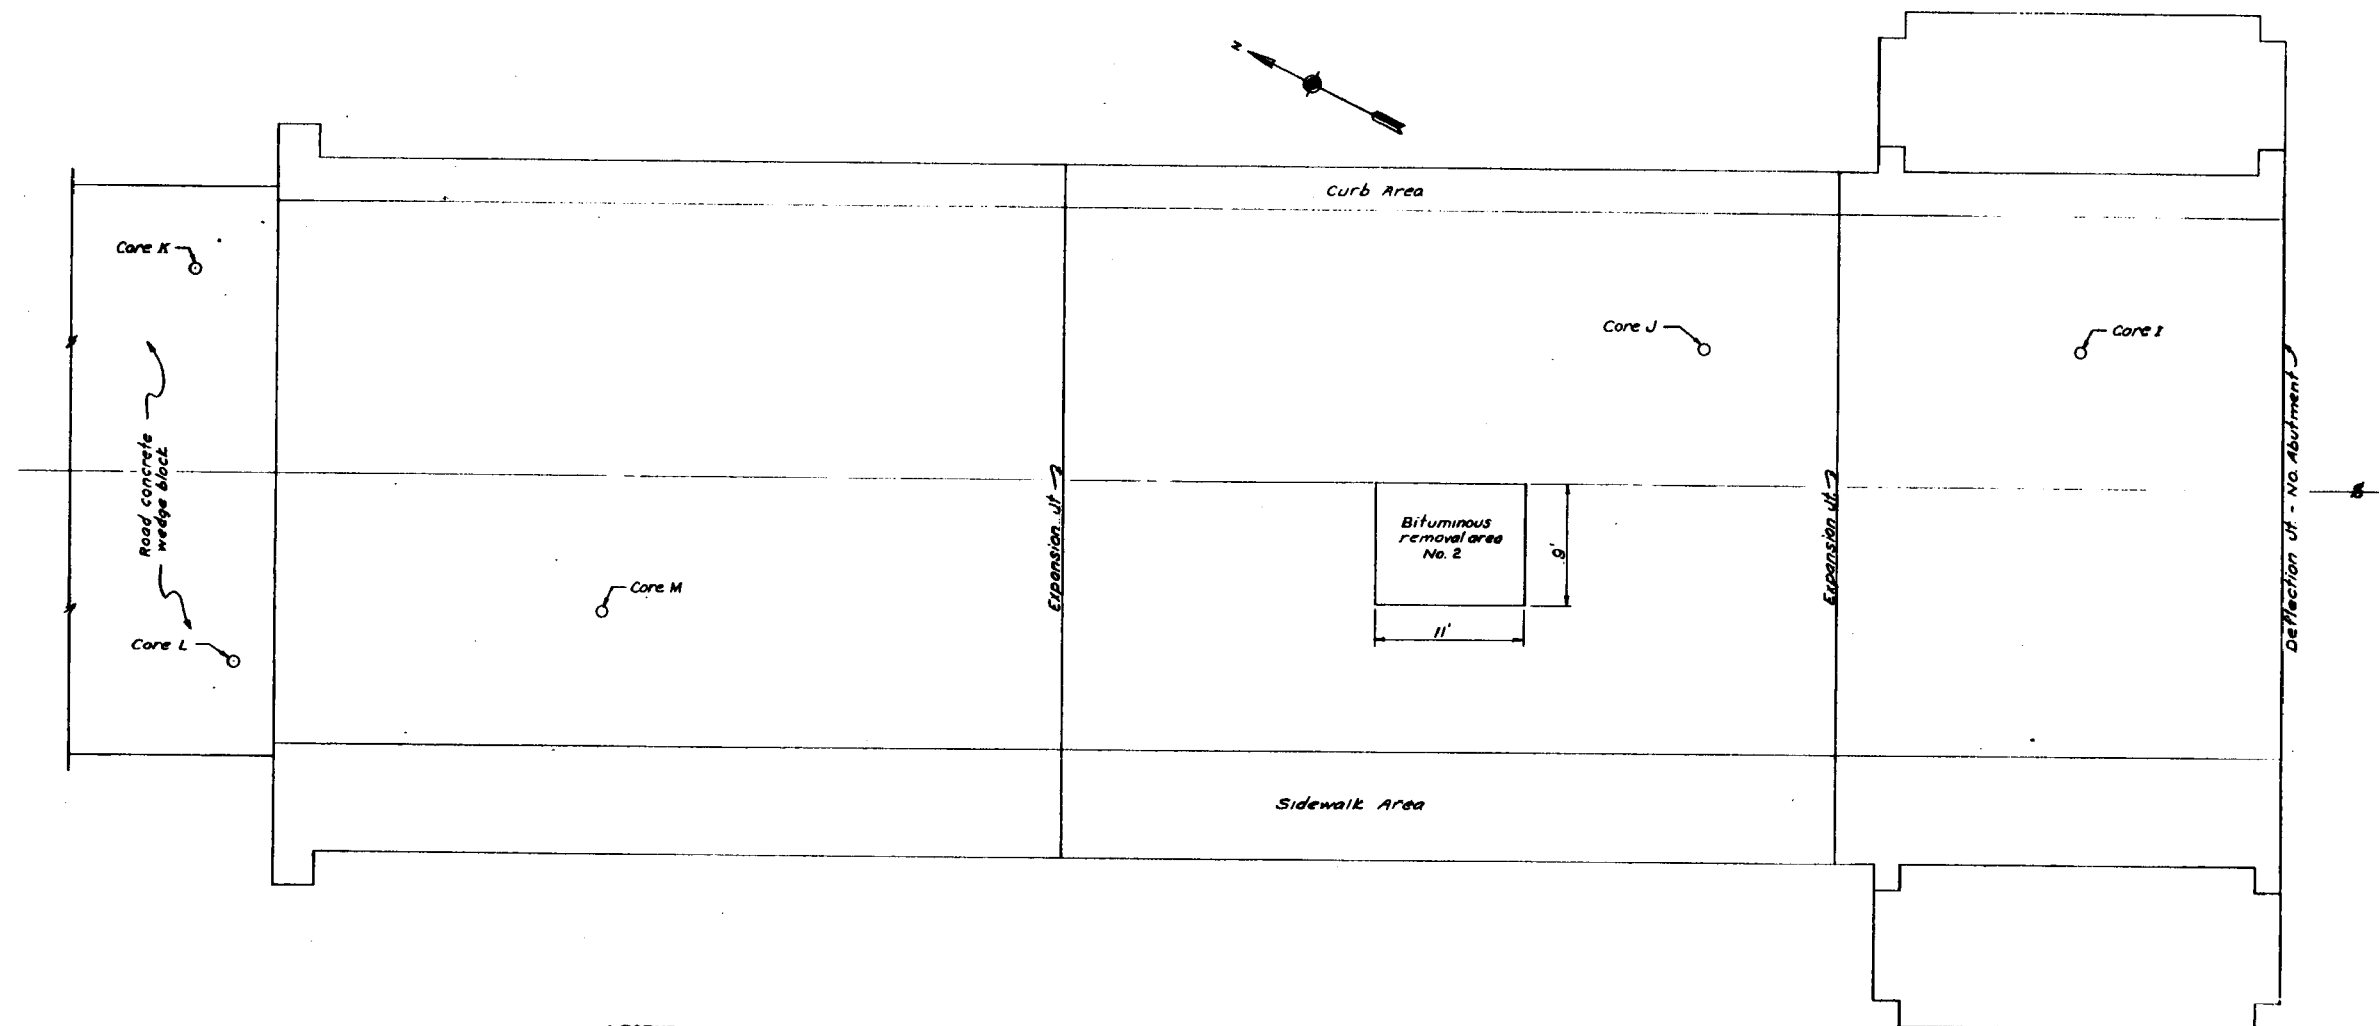
- Heavy lines indicate areas that exhibit heavy rusting of structural steel
- Light lines indicate the visual extent of staining due to leakage
- /// Slash lines indicate heavy flaking of concrete and exposure of reinforcing steel
- 2 Numerical designation within an area indicates the depth of spalling in inches of concrete in this area
- Bituminous removal areas indicate the location and extent of bituminous surface removal for exploratory purposes
- Location of 4 inch cores removed for exploratory purposes
- Location of 6 inch cores removed for exploratory purposes
- { } Lines indicate the location and visual extent of cracking accentuated by leakage
